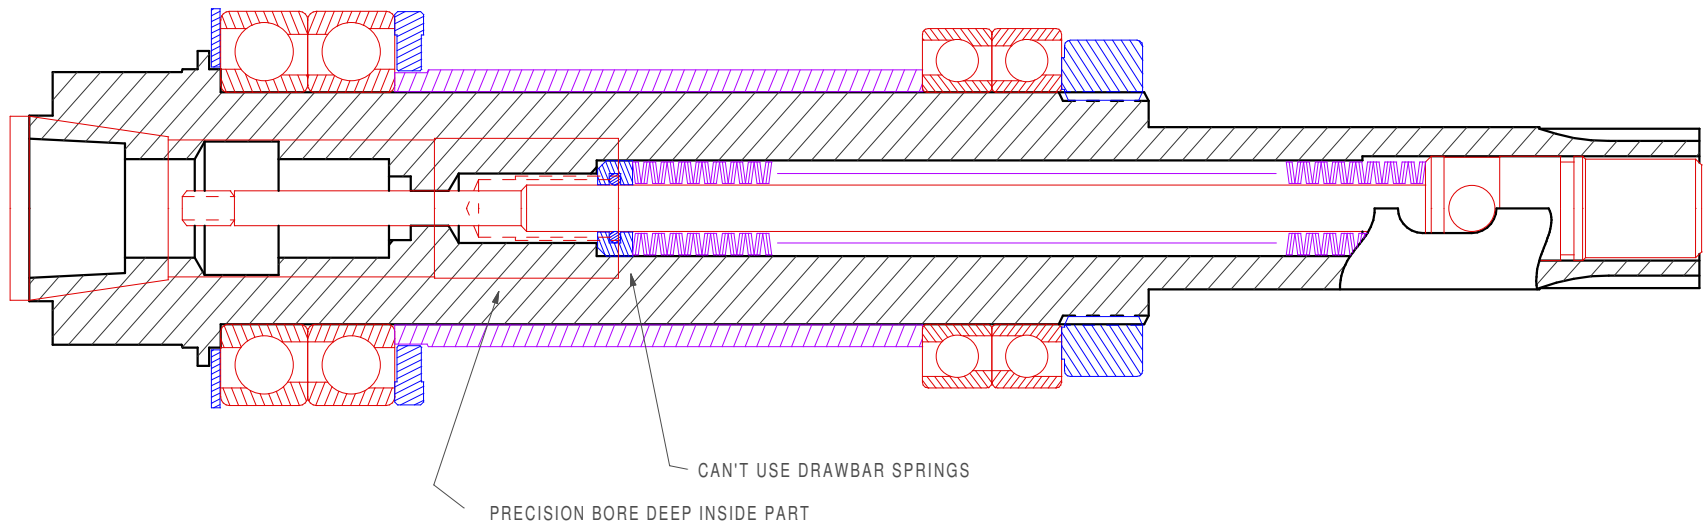
NOT ENOUGH METAL LEFT FOR SUPPORT

REMOVING SPINDLE FACE STEP
AND MOVING COLLET DEEPER
MAKES OTHER PROBLEMS WORSE

TAPER INTERSECTS PIN HOLE
